What Steam Pressure for Old Locomotive Boilers?

Ing. Livio Dante Porta

Foreword: Wolf Fengler, MSME

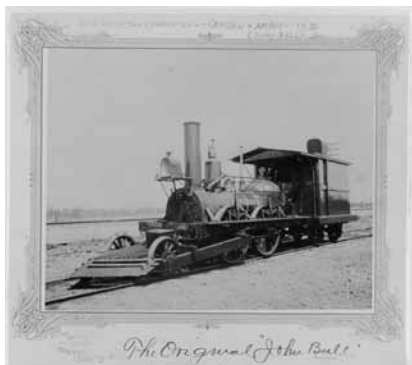
Cover Image - a Library of Congress photograph of the John Bull, an 1831-built steam locomotive that has operated as recently as 1981 in the U.S.

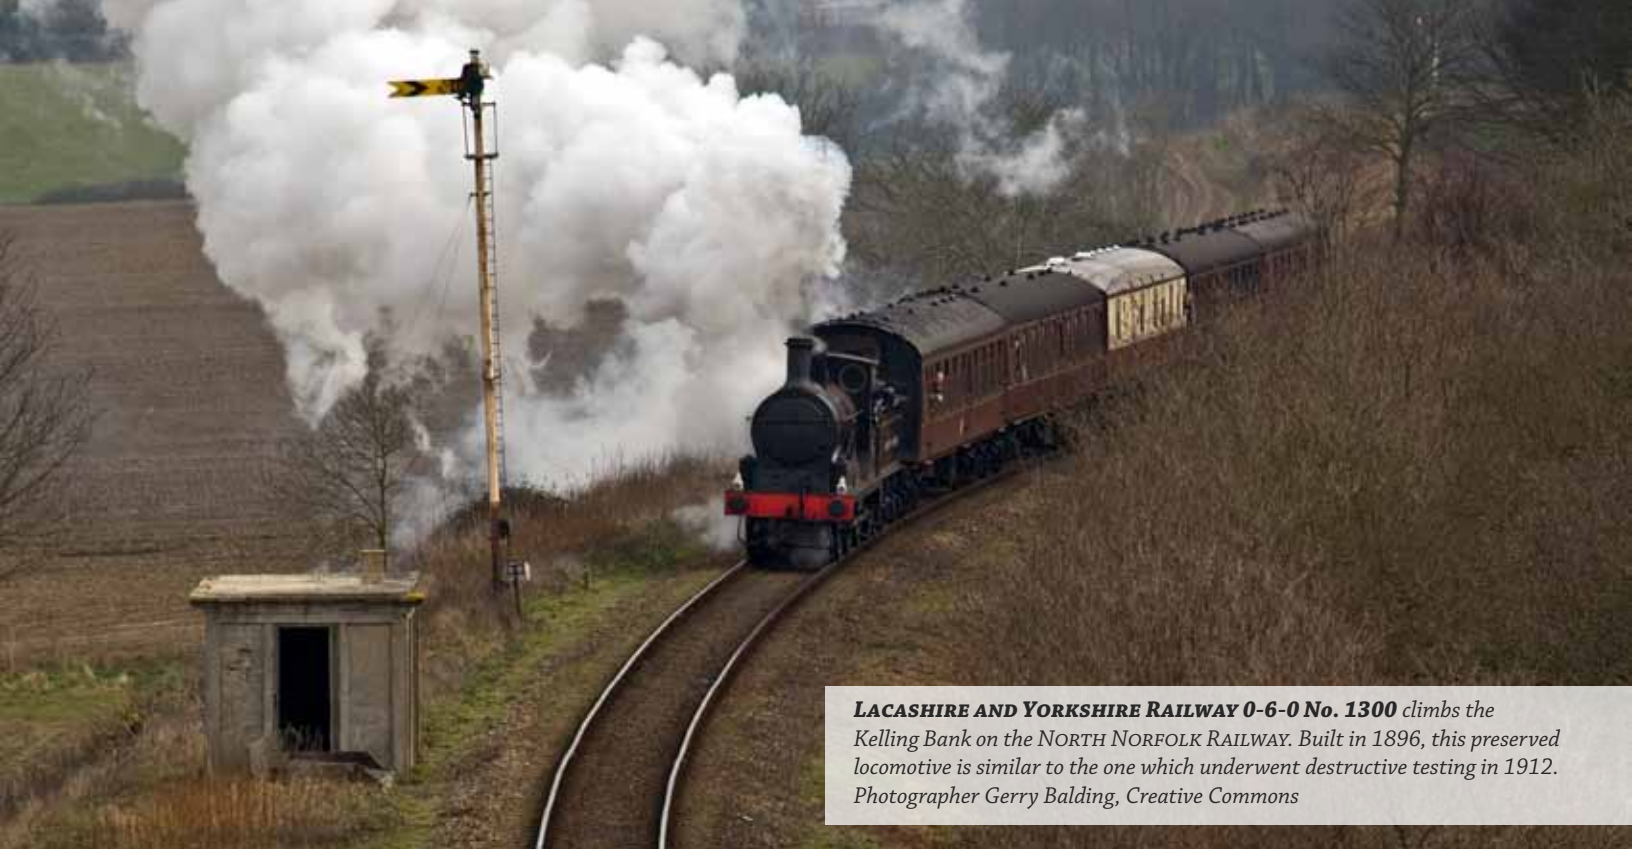
LACASHIRE AND YORKSHIRE RAILWAY 0-6-0 No. 1300 climbs the Kelling Bank on the NORTH NORFOLK RAILWAY. Built in 1896, this preserved locomotive is similar to the one which underwent destructive testing in 1912. Photographer Gerry Balding, Creative Commons

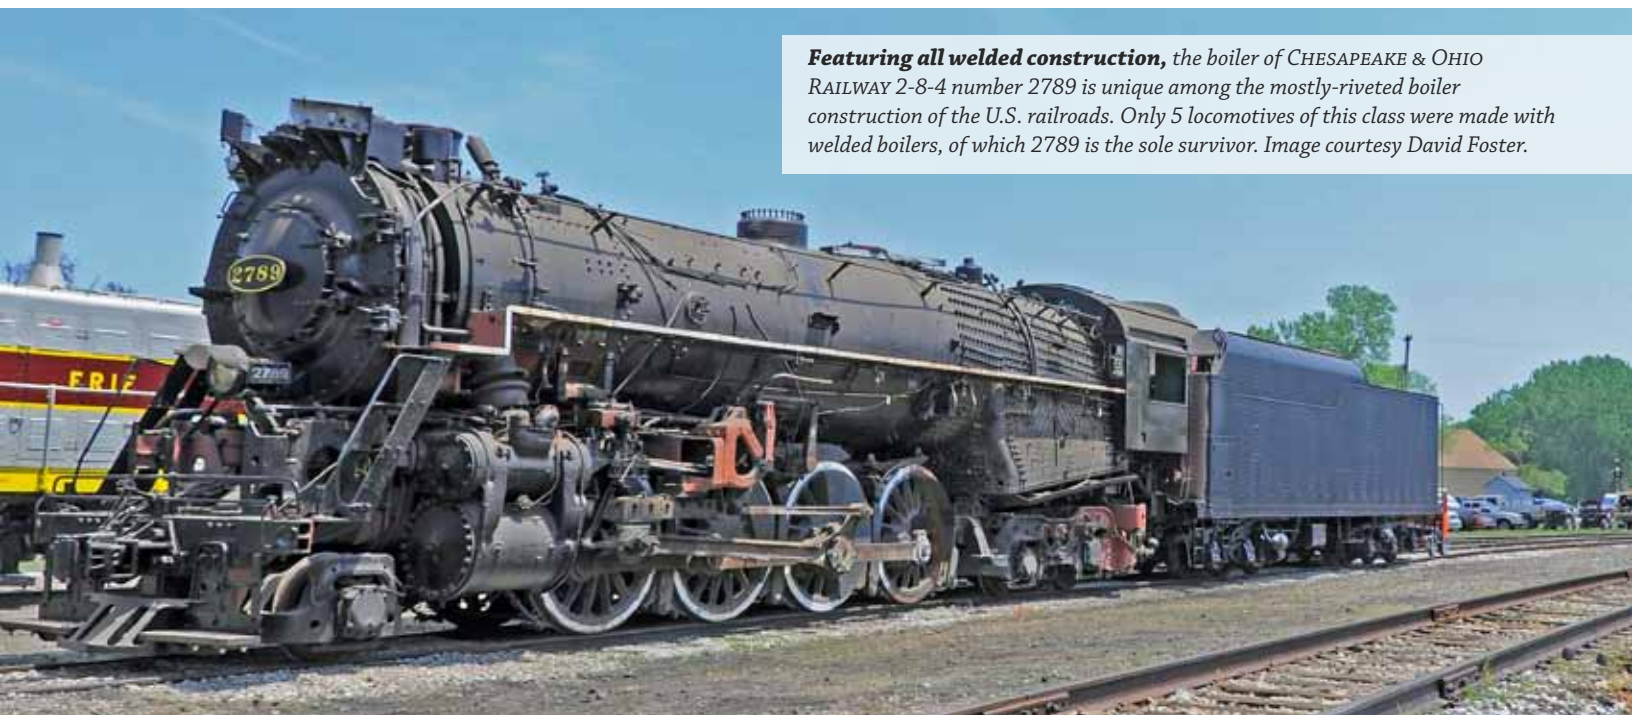
Featuring all welded construction, the boiler of CHESAPEAKE & OHIO RAILWAY 2-8-4 number 2789 is unique among the mostly-riveted boiler construction of the U.S. railroads. Only 5 locomotives of this class were made with welded boilers, of which 2789 is the sole survivor. Image courtesy David Foster.

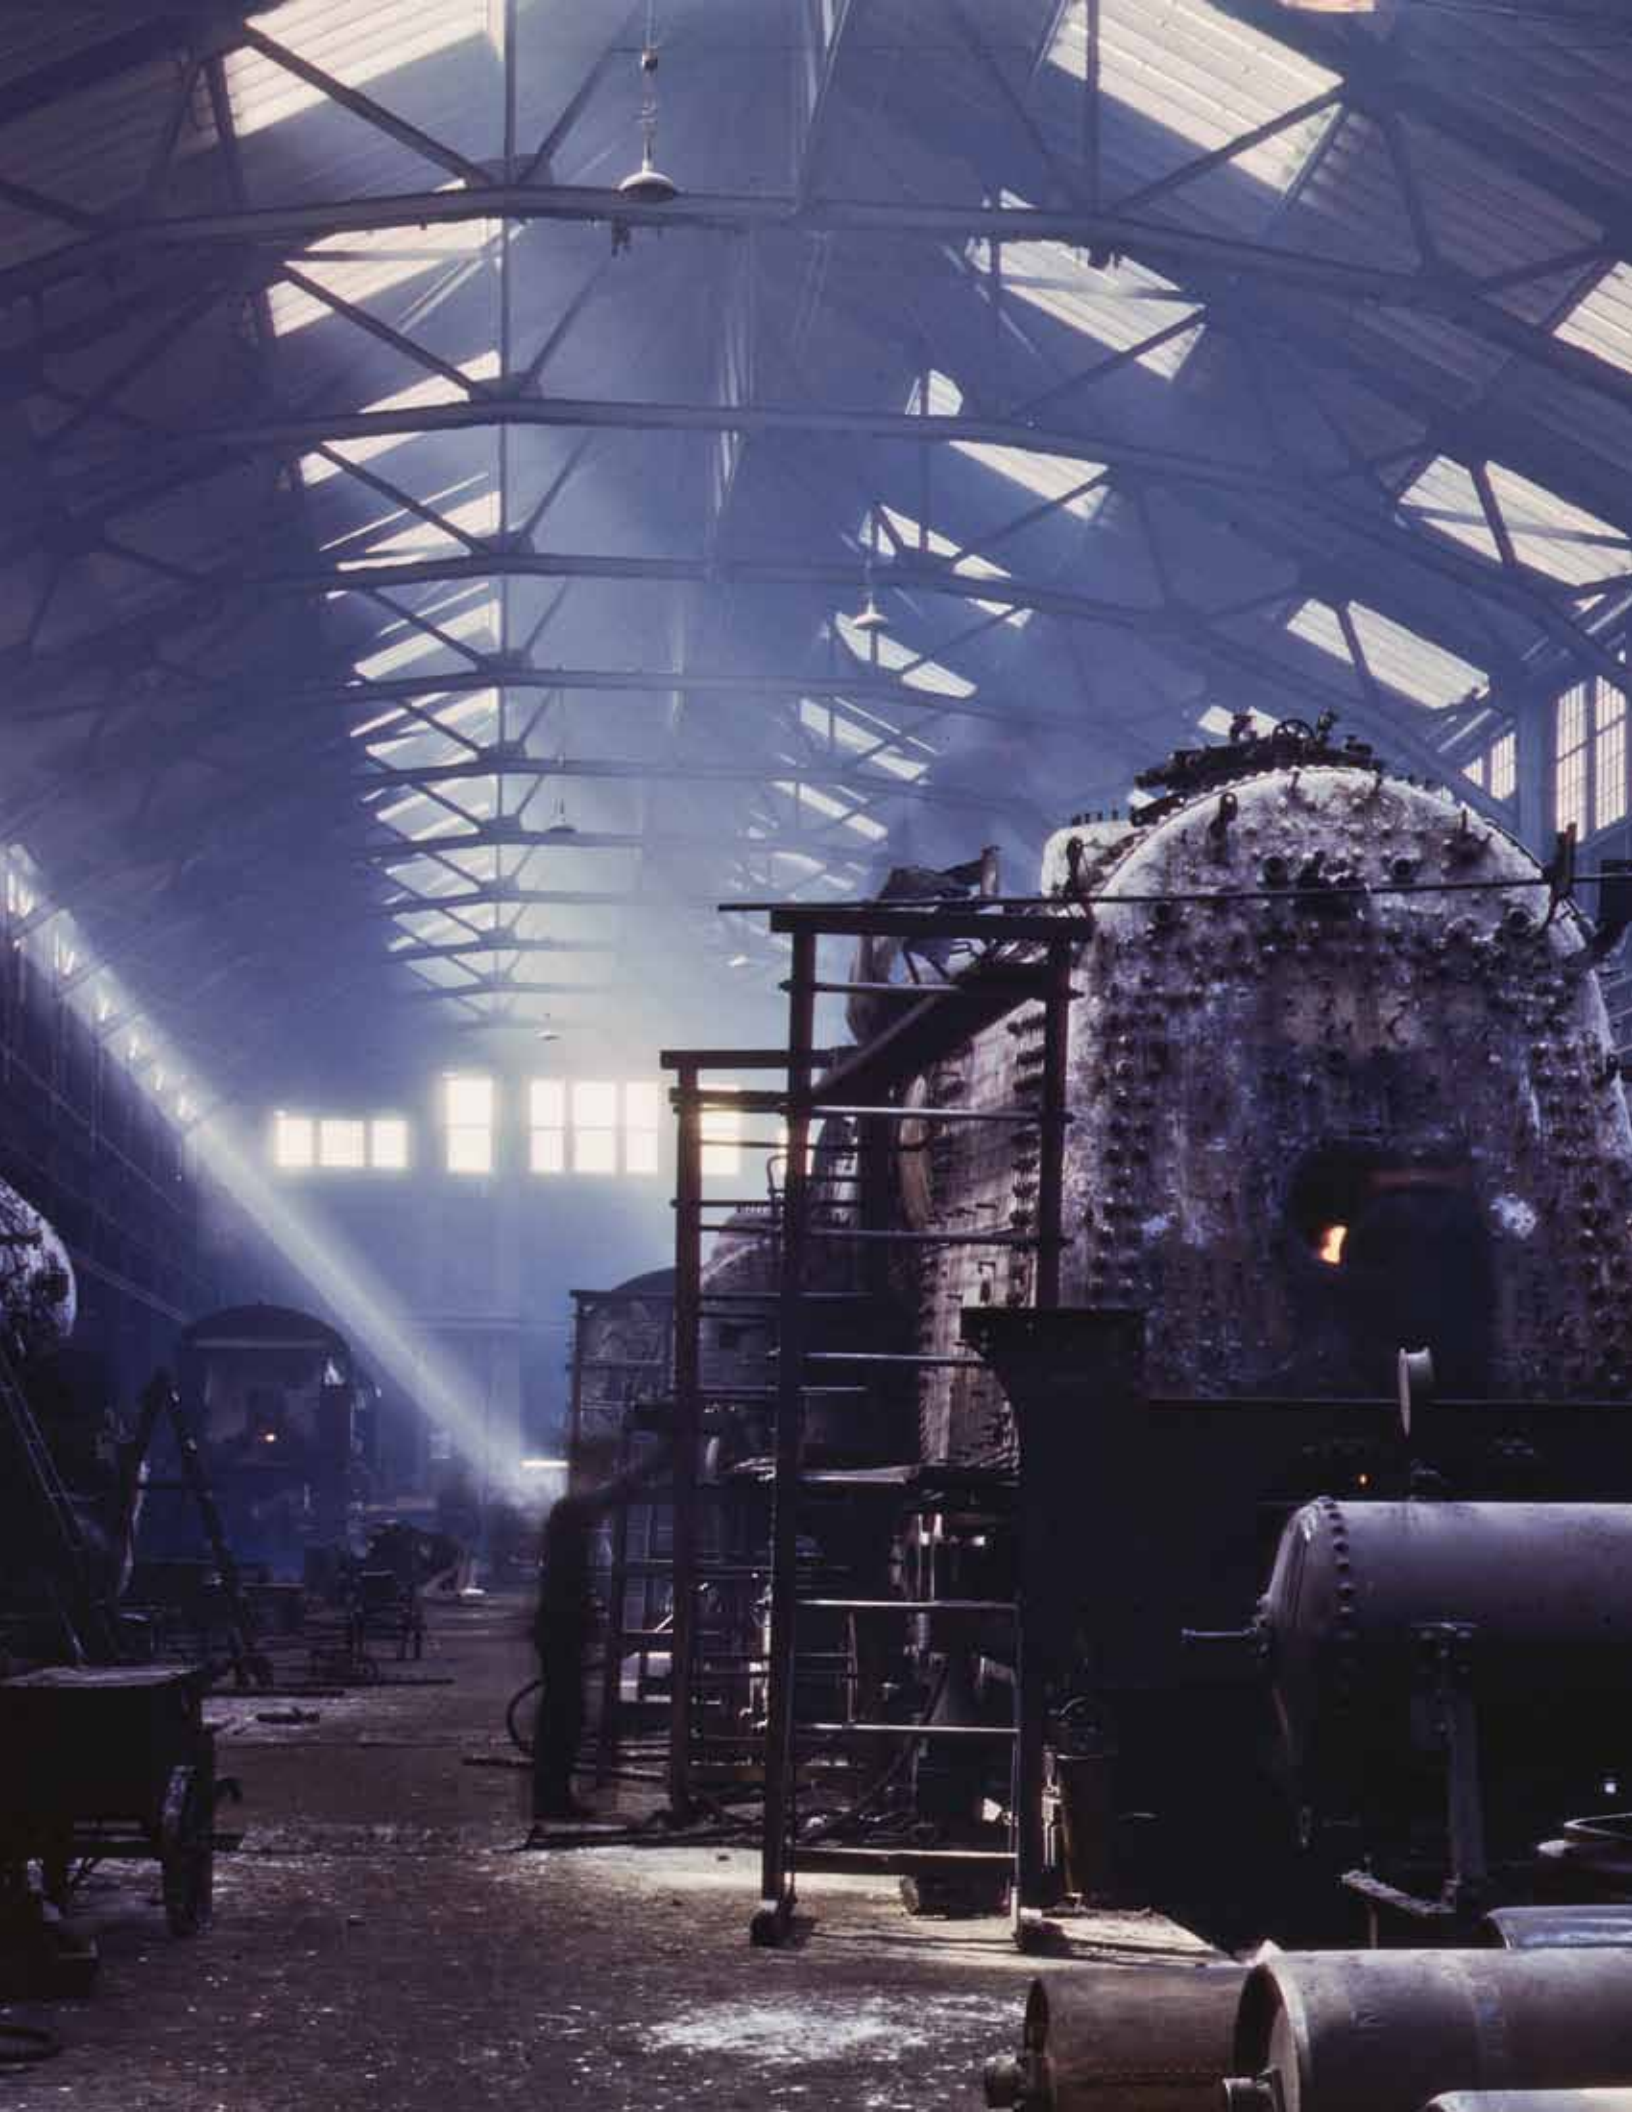
Millions upon millions of rivets. *This color photograph taken by Jack Delano, and courtesy of the Library of Congress, shows the Topeka shops of the Atchison, Topeka & Santa Fe Railway in March 1943. The railroad thrived on the use of rivets not only in joining boiler seams, but also in fabricating tenders, air compressor tanks, and even the trusses holding up the shop roof.*

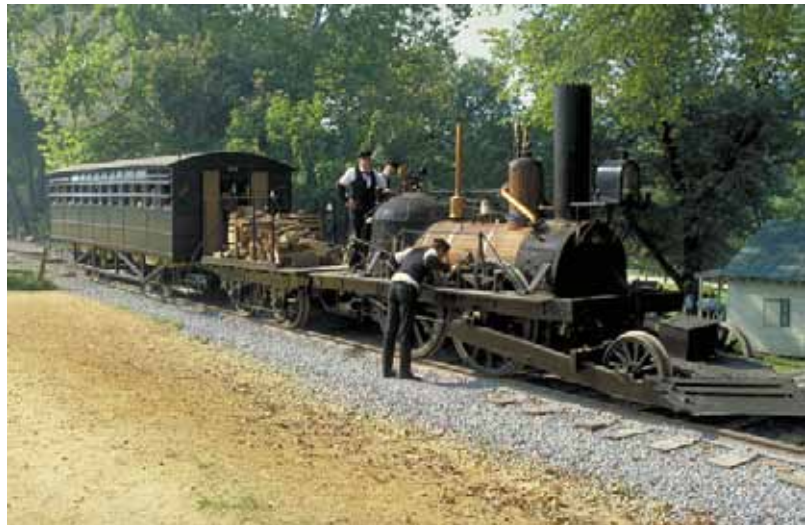
The oldest one of them all. *The CAMDEN AND AMBOY RAILROAD took delivery of the 4-2-0 locomotive known as “John Bull” in 1831 from ROBERT STEPHENSON AND COMPANY. The locomotive was manufactured in England, then disassembled and shipped across the Atlantic Ocean. When it arrived, it was the responsibility of C&A Mechanical Engineer Isaac Dripps to reconstruct the locomotive, but it did not have any accompanying drawings and Dripps had never seen a locomotive before!*

The locomotive was delivered by its manufacturer as an 0-4-0, with power transmitted to the driving wheels by two inside cylinders that connected to a rear crank axle with connecting rods to the front axle. The quality of track in the U.S. was much poorer at that time than in England, and the engine was soon found to be prone to derailment.

Mechanical engineers at the C&A retrofitted the locomotive with a lead pony truck (two wheels) to help guide the engine through curves. The design of the lead truck required the removal of the connecting rod between the number two and number one powered axles, effectively making the locomotive a 4-2-0. This was the first implementation of the four wheel lead truck arrangement that eventually morphed into the 4-4-0, or “American Standard” wheel arrangement that was robust enough to support the westward expansion of the U.S.

The locomotive mostly lived indoors at the Smithsonian, traveling on special occasions to outside venues. Most notably was the restoration to operation of the locomotive by William L. Withuhn and John H. White in the 1980's. Beginning in January 1980, the Smithsonian undertook tests with compressed air and, later, ultrasonic equipment to gauge the soundness of the boiler.

In the end, it was determined that John Bull could operate safely at 50 PSI (down from as-manufactured 70 PSI). The locomotive was operated in celebration of its sesquicentennial on a select few excursions on branch lines near Washington, D.C., in 1980 and 1981. It became the oldest operable self-propelled vehicle in the world at these events.
